# Flame sensors without water cooling offer significant benefits for gas turbines

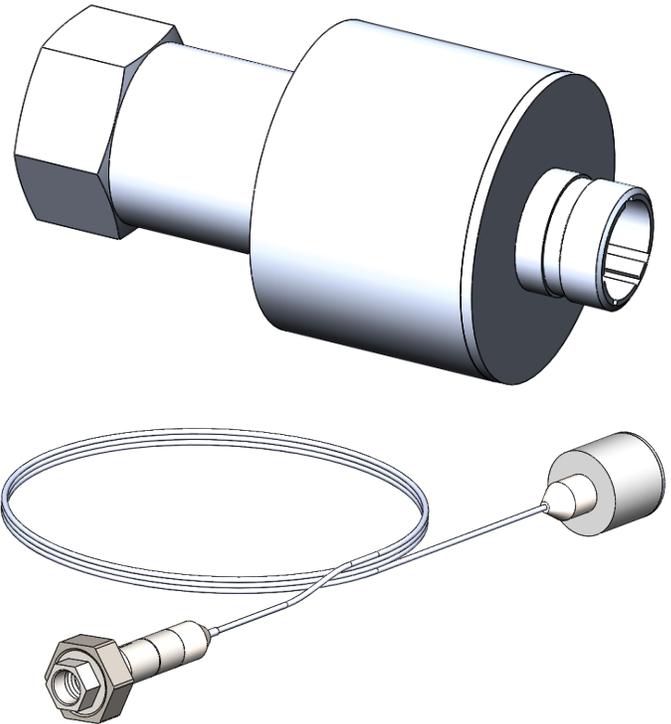
Built on the proven Silicon Carbide sensing element used in the Flame Tracker, the FTD 325 system takes advantage of a remote electronics configuration that places a sensing element capable of operation at temperatures up to 325°C in the hot end of the sensor and moves the temperature-sensitive electronics to a low spot in the turbine compartment where temperatures are below its 150°C operational limits. The electrical signal from the hot end is transmitted to the cool end via a 30-foot long mineral insulated cable.

Gas turbines use one of two flame sensors from Reuter-Stokes—the Flame Tracker or the Flame Tracker Dry 325 (FTD 325). In use for many years, the Flame Tracker employs a water-cooling system to keep the sensor temperature below 150°C. Conversely, the FTD 325 uses innovative remote electronics technology to eliminate the need for water cooling on both the hot and cool end of the sensor.

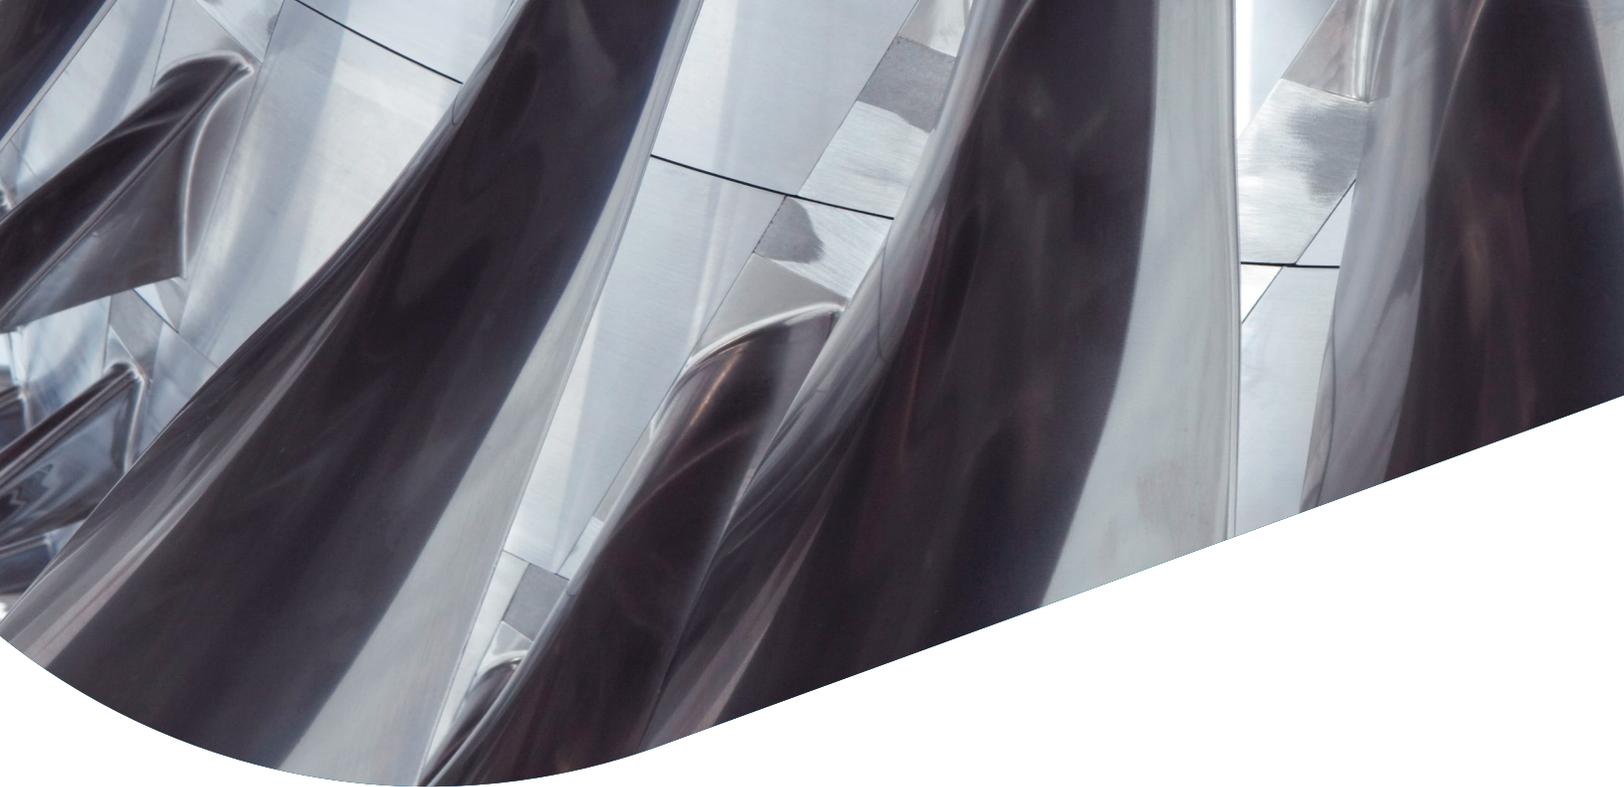
**Overheating failures.** While the maximum operating temperature for the Flame Tracker is 150°C, the ambient air around the sensor can reach temperatures as high as 280°C. This means that when the water-cooling system fails, the Flame Tracker can quickly overheat and incur damage. A variety of different failure modes—from water lines blocked due to hard water deposits, biological growth, silt, corrosion, and freezing, to the occasional forgetful operator who fails to turn on the cooling water valves after an outage—can inhibit sufficient water cooling, leading to Flame Tracker malfunction and often permanent damage.
